1962 to 1942
Morning Sun Lane
Naples, FL
34119

Client Name **Club Homes I**

Uniform Mitigation Verification Inspection Form

Photo Report

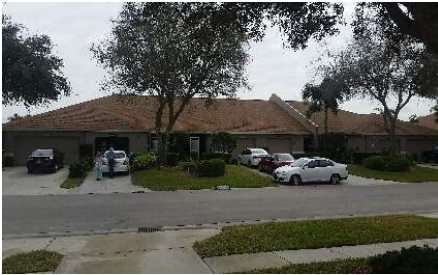
1.

Location: Throughout **System:** Wind Mitigation **Condition:** Front
Explanation: Photo of Front showing Glazed and Non Glazed openings
Impact Consequences: Style of roof should be evident if accessibility allows
Recommended Action: Predominant Roof Covering should be viewable if access allows

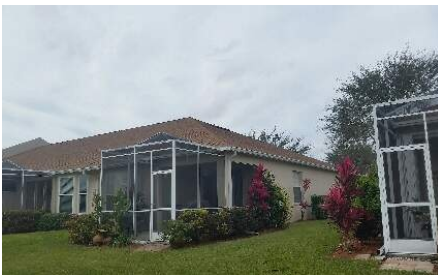
3.

Location: Throughout **System:** Wind Mitigation **Condition:** Left
Explanation: Photo of left Side showing Glazed and Non Glazed openings
Impact Consequences: Style of roof should be evident if accessibility allows
Recommended Action: Predominant Roof Covering should be viewable if access allows

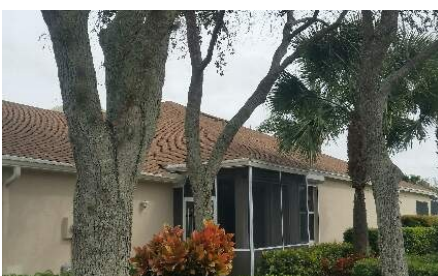
4.

Location: Throughout **System:** Wind Mitigation **Condition:** Right
Explanation: Photo of right Side showing Glazed and Non Glazed openings

Impact Consequences: Style of roof should be evident if accessibility allows
Recommended Action: Predominant Roof Covering should be viewable if access allows

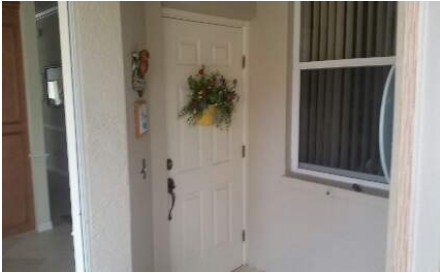
5.

Location: Throughout **System:** Wind Mitigation **Condition:** Detail photo of Door
Explanation: Evidence of hurricane protection if applicable
Impact Consequences: No Comment
Recommended Action: No Comment

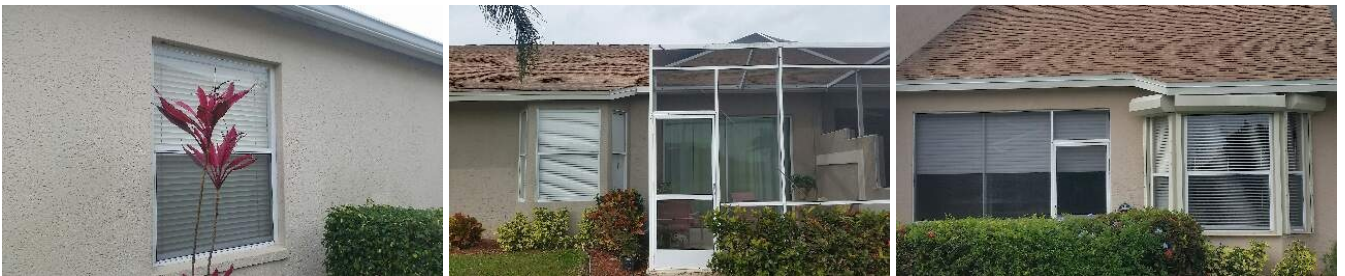
6.

Location: Throughout **System:** Wind Mitigation **Condition:** Detailed Photo Of Glazed Opening
Explanation: Close up detailed photo of glazed exterior opening
Impact Consequences: Photo showing details of glazed exterior openings.
Recommended Action: For Review

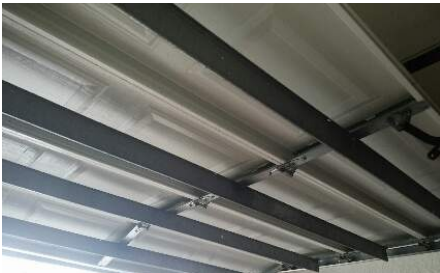
7.

Location: Throughout **System:** Wind Mitigation **Condition:** Garage Door Upgrade Recommended
Explanation: An upgraded garage door with a FBC approval is recommended.
Impact Consequences: Consider upgrading the door in order to obtain additional credits towards insurance premium discounts.
Recommended Action: Review

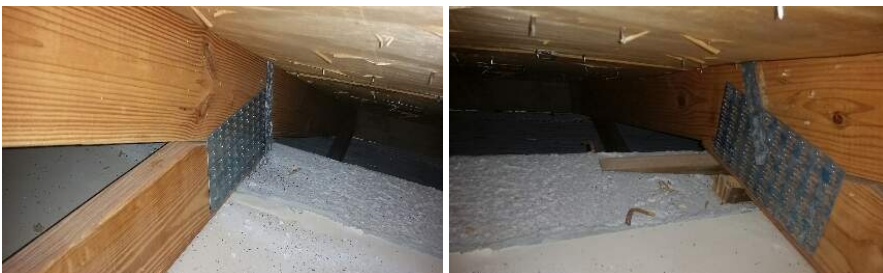
8.

Location: Throughout **System:** Wind Mitigation **Condition:** Photo showing detail of a Single Wrap Detail
Explanation: Single Wraps Metal Straps must be secured to every rafter and or truss with a minimum of 3 nails wrapping over and securing to the opposite side of the rafter and or truss with a minimum of 1 nail. The Strap must be attached to the top plate of the wall frame or embedded in the bond beam in at least one place.
Impact Consequences: No Comment

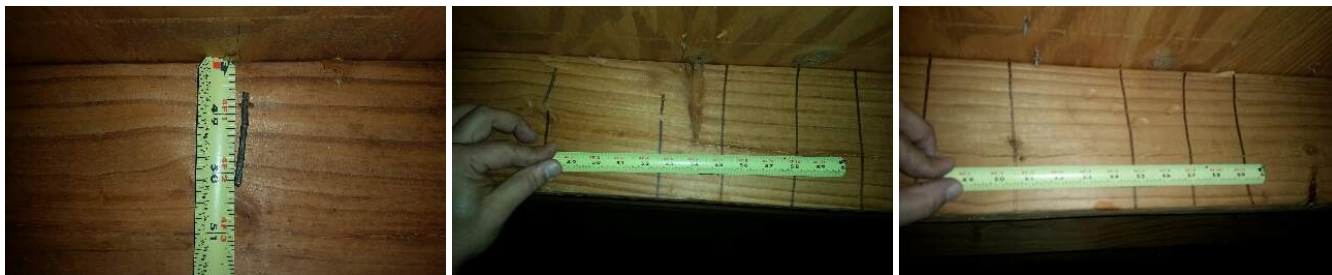
9.

Location: Throughout **System:** Wind Mitigation **Condition:** Photo showing detail of a Field Nailing

Explanation: Field Nailing Detail Photo

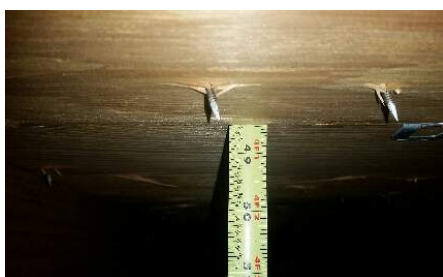
10.

Location: Throughout **System:** Wind Mitigation **Condition:** Photo Of Plywood Thickness

Explanation: Field Measurement
