1938 to 1918
Morning Sun Lane
Naples, FL
34119

Uniform Mitigation Verification Inspection Form

Inspection Date: 02/15/2016		Report Number 261	
Owner Information			
Owner Name: Club Homes I		Contact Person: Club Homes I	
Address: 1938 to 1918 Morning Sun Lane		Home Phone:	
City: Naples	Zip: 34119	Work Phone:	
County:		Cell Phone:	
Insurance Company:		Policy #:	
Year of Home:	# of Stories: Single Floor	Email: jneubs@att.net

Photo Report

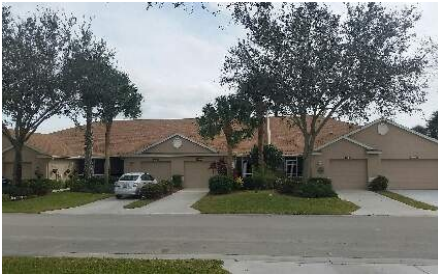
1.

Location: Throughout **System:** Wind Mitigation **Condition:** Front
Explanation: Photo of Front showing Glazed and Non Glazed openings
Impact Consequences: Style of roof should be evident if accessibility allows
Recommended Action: Predominant Roof Covering should be viewable if access allows

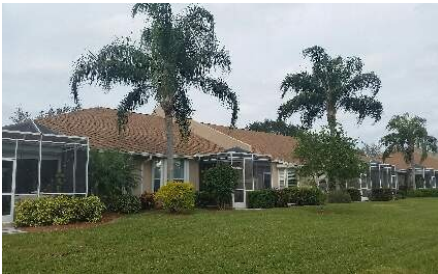
2.

Location: Throughout **System:** Wind Mitigation **Condition:** Back
Explanation: Photo of back showing Glazed and Non Glazed openings
Impact Consequences: Style of roof should be evident if accessibility allows
Recommended Action: Predominant Roof Covering should be viewable if access allows

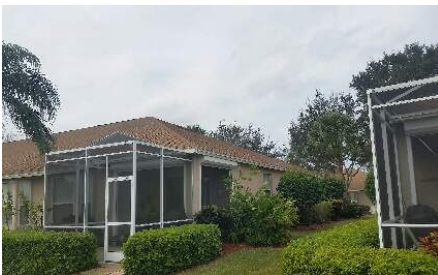
3.

Location: Throughout **System:** Wind Mitigation **Condition:** Left
Explanation: Photo of left Side showing Glazed and Non Glazed openings
Impact Consequences: Style of roof should be evident if accessibility allows
Recommended Action: Predominant Roof Covering should be viewable if access allows

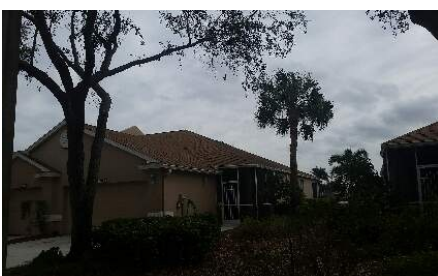
4.

Location: Throughout **System:** Wind Mitigation **Condition:** Right
Explanation: Photo of right Side showing Glazed and Non Glazed openings

Impact Consequences: Style of roof should be evident if accessibility allows
Recommended Action: Predominant Roof Covering should be viewable if access allows

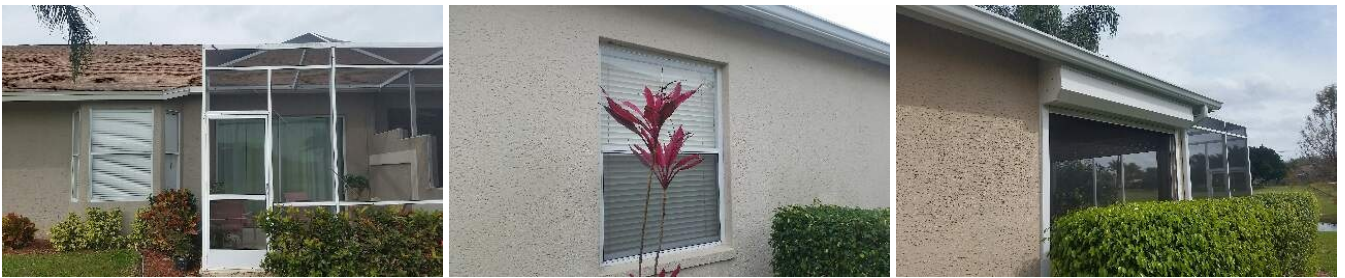
6.

Location: Throughout **System:** Wind Mitigation **Condition:** Detailed Photo Of Glazed Opening
Explanation: Close up detailed photo of glazed exterior opening
Impact Consequences: Photo showing details of glazed exterior openings.
Recommended Action: For Review

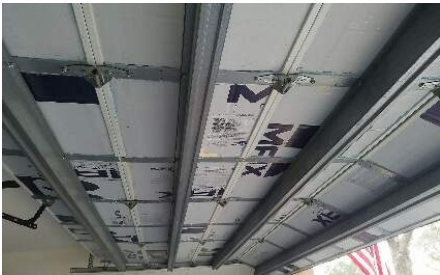
7.

Location: Throughout **System:** Wind Mitigation **Condition:** Photo showing details of Garage Door
Explanation: No Comment
Impact Consequences: No Comment
Recommended Action: No Comment

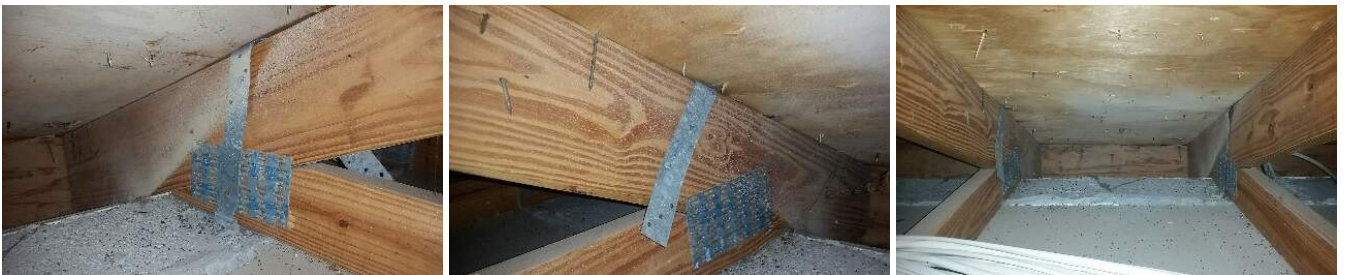
8.

Location: Throughout **System:** Wind Mitigation **Condition:** Photo showing detail of a Single Wrap Detail
Explanation: Single Wraps Metal Straps must be secured to every rafter and or truss with a minimum of 3 nails wrapping over and securing to the opposite side of the rafter and or truss with a minimum of 1 nail. The Strap must be attached to the top plate of the wall frame or embedded in the bond beam in at least one place.
Impact Consequences: No Comment
Recommended Action: No Comment

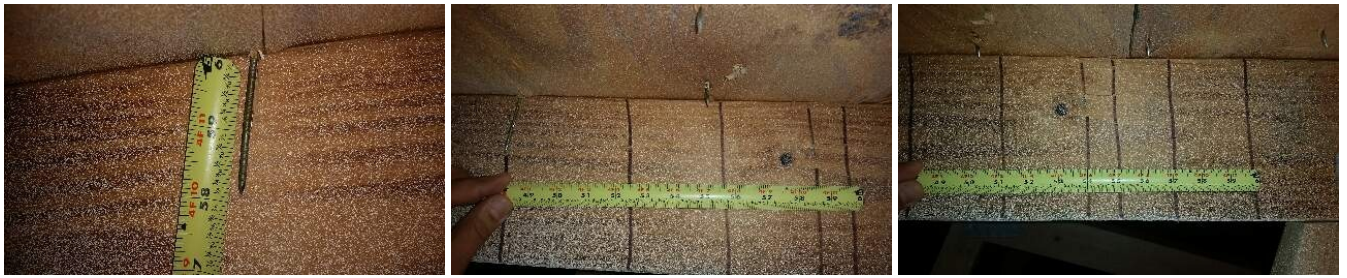
9.

Location: Throughout **System:** Wind Mitigation **Condition:** Photo showing detail of a Field Nailing

Explanation: Field Nailing Detail Photo

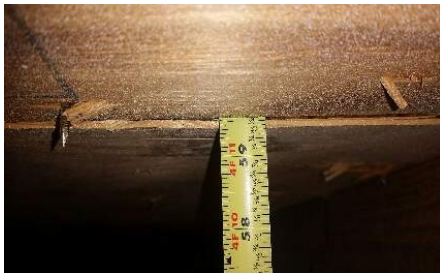
10.

Location: Throughout **System:** Wind Mitigation **Condition:** Photo Of Plywood Thickness

Explanation: Field Measurement
