**1818-1798 Morning Sun  
Lane**  
Naples, FL  
33908

Inspection Date: **04/23/2019**

# Uniform Mitigation Verification Inspection Form

# Photo Report

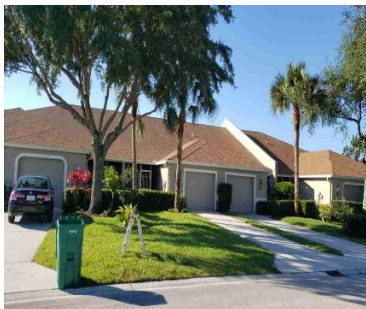
1.

**Location:** Exterior **System:** Wind Mitigation **Condition:** Front

**Explanation:** Photo of Front showing Glazed and Non Glazed openings

**Impact Consequences:** Style of roof should be evident if accessibility allows

**Recommended Action:** Predominant Roof Covering should be viewable if access allows

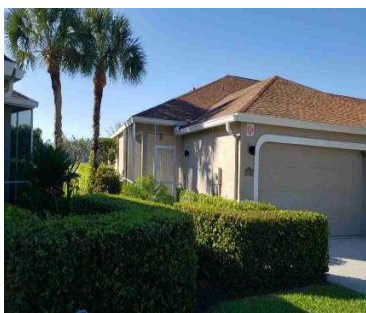
2.

**Location:** Exterior **System:** Wind Mitigation **Condition:** Left

**Explanation:** Photo of left Side showing Glazed and Non Glazed openings

**Impact Consequences:** Style of roof should be evident if accessibility allows

**Recommended Action:** Predominant Roof Covering should be viewable if access allows

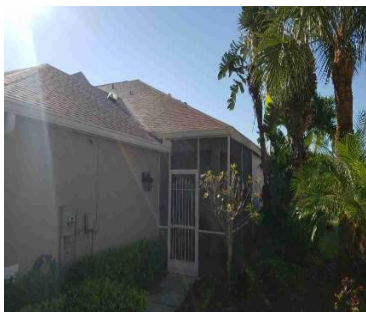
3.

**Location:** Exterior **System:** Wind Mitigation **Condition:** Right

**Explanation:** Photo of right Side showing Glazed and Non Glazed openings

**Impact Consequences:** Style of roof should be evident if accessibility allows

**Recommended Action:** Predominant Roof Covering should be viewable if access allows

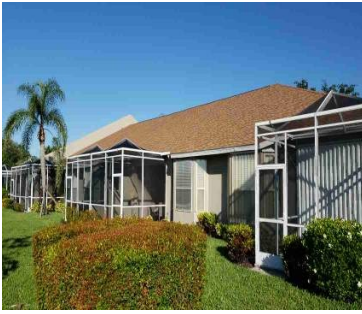
4.

**Location:** Exterior **System:** Wind Mitigation **Condition:** Back  
**Explanation:** Photo of back showing Glazed and Non Glazed openings  
**Impact Consequences:** Style of roof should be evident if accessibility allows  
**Recommended Action:** Predominant Roof Covering should be viewable if access allows

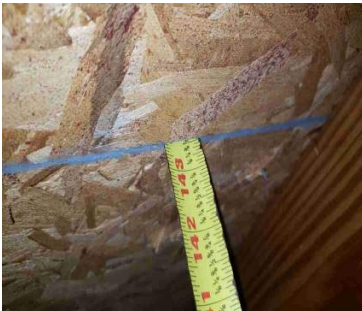
## 5.

**Location:** Attic **System:** Wind Mitigation **Condition:** Photo Of Plywood Thickness  
**Explanation:** Field Measurement  
**Impact Consequences:** NA  
**Recommended Action:** NA

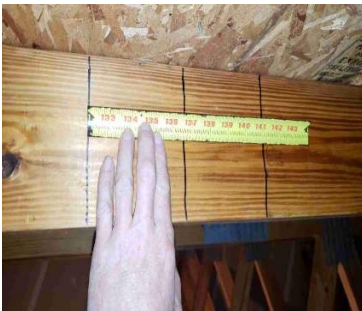
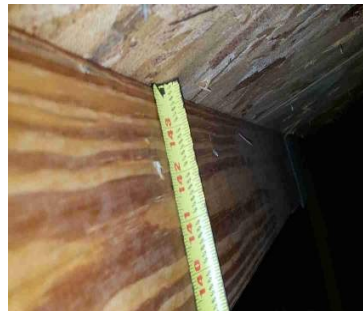
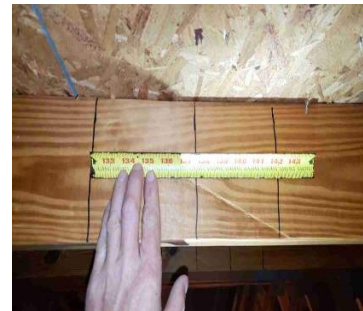
## 6.

**Location:** Attic **System:** Wind Mitigation **Condition:** Photo showing detail of a Field Nailing  
**Explanation:** Field Nailing Detail Photo  
**Impact Consequences:** No Comment  
**Recommended Action:** No Comment

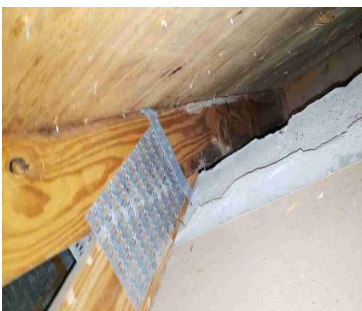
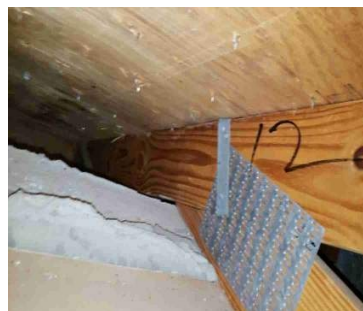
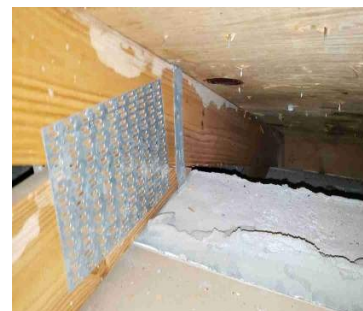
## 7.

**Location:** Attic **System:** Wind Mitigation **Condition:** Photo showing detail of a Single Wrap Detail  
**Explanation:** Single Wraps Metal Straps must be secured to every rafter and or truss with a minimum of 3 nails wrapping over and securing to the opposite side of the rafter and or truss with a minimum of 1 nail. The Strap must be attached to the top

plate of the wall frame or embedded in the bond beam in at least one place.
