1914-1894 Morning
Sun Lane
Naples, FL
34119

Inspection Date: **02/15/2016**

Uniform Mitigation Verification Inspection Form

Photo Report

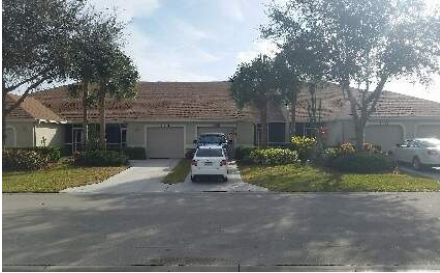
1.

Location: Throughout **System:** Wind Mitigation **Condition:** Front
Explanation: Photo of Front showing Glazed and Non Glazed openings
Impact Consequences: Style of roof should be evident if accessibility allows
Recommended Action: Predominant Roof Covering should be viewable if access allows

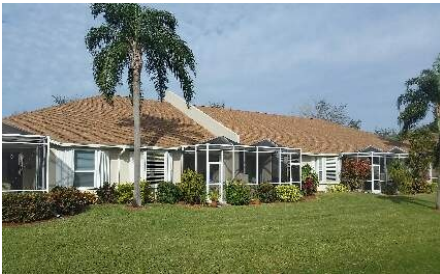
2.

Location: Throughout **System:** Wind Mitigation **Condition:** Back
Explanation: Photo of back showing Glazed and Non Glazed openings
Impact Consequences: Style of roof should be evident if accessibility allows
Recommended Action: Predominant Roof Covering should be viewable if access allows

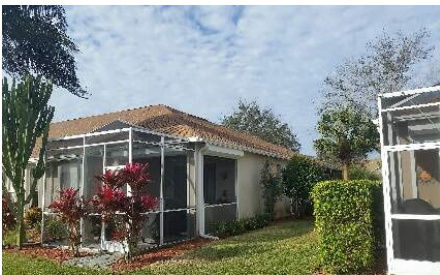
3.

Location: Throughout **System:** Wind Mitigation **Condition:** Left
Explanation: Photo of left Side showing Glazed and Non Glazed openings
Impact Consequences: Style of roof should be evident if accessibility allows
Recommended Action: Predominant Roof Covering should be viewable if access allows

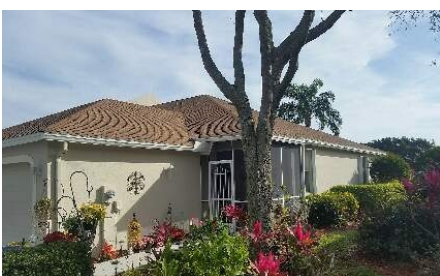
4.

Location: Throughout **System:** Wind Mitigation **Condition:** Right
Explanation: Photo of right Side showing Glazed and Non Glazed openings

Impact Consequences: Style of roof should be evident if accessibility allows
Recommended Action: Predominant Roof Covering should be viewable if access allows

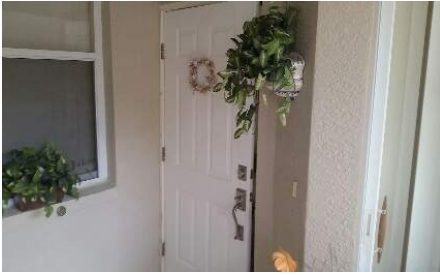
5.

Location: Throughout **System:** Wind Mitigation **Condition:** Detail photo of Door
Explanation: Evidence of hurricane protection if applicable
Impact Consequences: No Comment
Recommended Action: No Comment

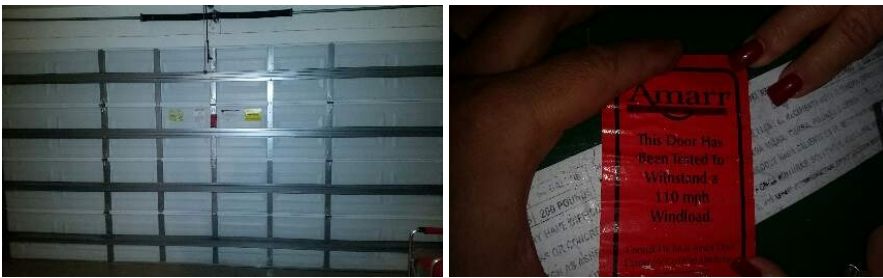
6.

Location: Throughout **System:** Wind Mitigation **Condition:** Photo showing details of Garage Door
Explanation: No Comment
Impact Consequences: No Comment
Recommended Action: No Comment

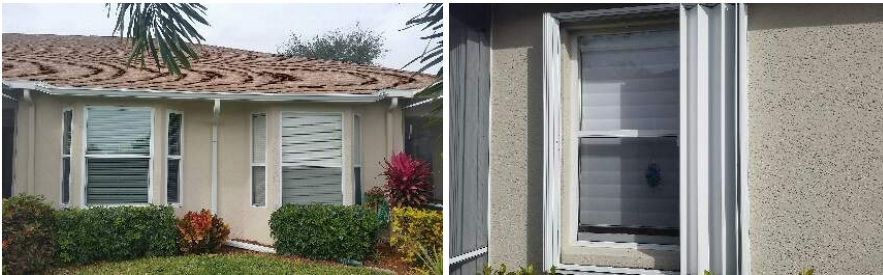
7.

Location: Throughout **System:** Wind Mitigation **Condition:** Detailed Photo Of Glazed Opening
Explanation: Close up detailed photo of glazed exterior opening
Impact Consequences: Photo showing details of glazed exterior openings.
Recommended Action: For Review

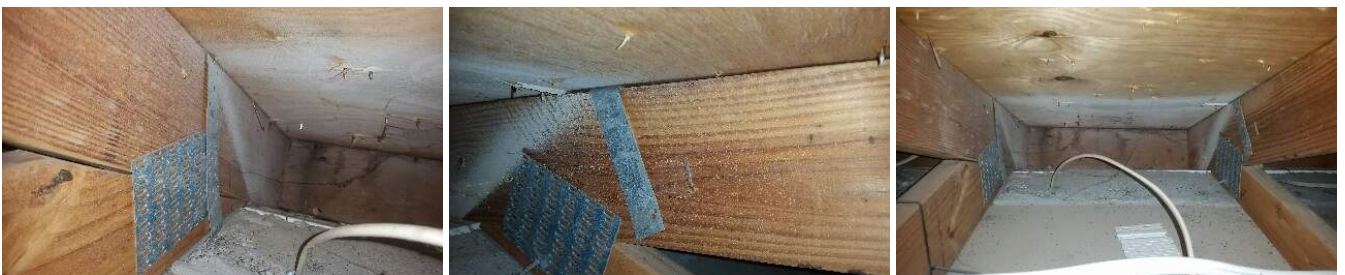
8.

Location: Throughout **System:** Wind Mitigation **Condition:** Photo showing detail of a Single Wrap Detail
Explanation: Single Wraps Metal Straps must be secured to every rafter and or truss with a minimum of 3 nails wrapping over and securing to the opposite side of the rafter and or truss with a minimum of 1 nail. The Strap must be attached to the top plate of the wall frame or embedded in the bond beam in at least one place.
Impact Consequences: No Comment
Recommended Action: No Comment

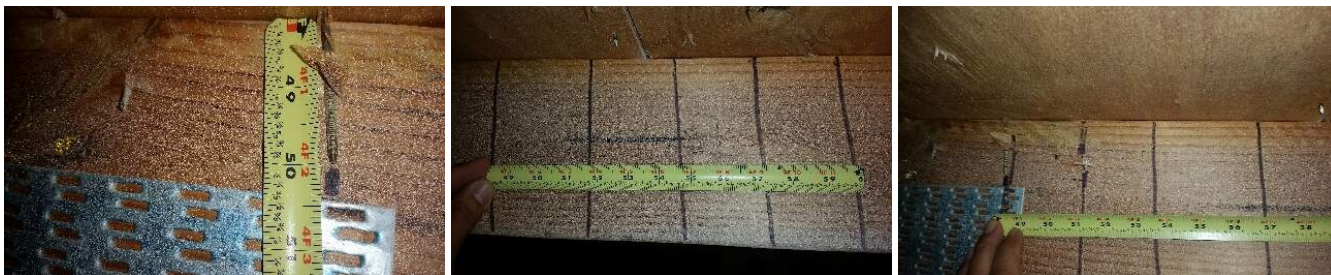
9.

Location: Throughout **System:** Wind Mitigation **Condition:** Photo showing detail of a Field Nailing

Explanation: Field Nailing Detail Photo

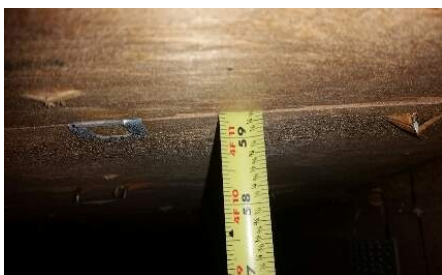
10.

Location: Throughout **System:** Wind Mitigation **Condition:** Photo Of Plywood Thickness

Explanation: Field Measurement
