**1842-1822 Morning Sun  
Lane**  
Naples, FL  
33908

Client Name **Club Homes 1 at Heritage  
Greens**

## Uniform Mitigation Verification Inspection Form

# Photo Report

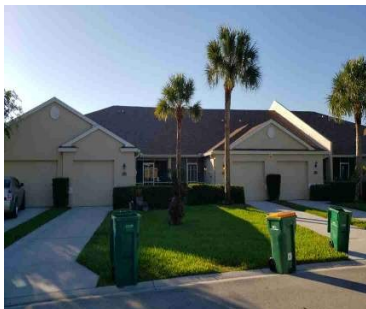
1.

**Location:** Exterior **System:** Wind Mitigation **Condition:** Front

**Explanation:** Photo of Front showing Glazed and Non Glazed openings

**Impact Consequences:** Style of roof should be evident if accessibility allows

**Recommended Action:** Predominant Roof Covering should be viewable if access allows

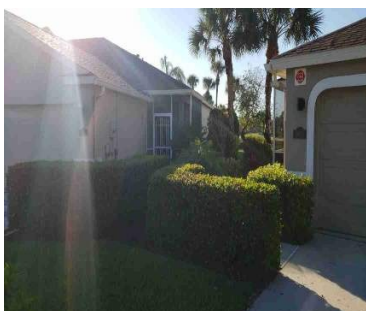
2.

**Location:** Exterior **System:** Wind Mitigation **Condition:** Right

**Explanation:** Photo of right Side showing Glazed and Non Glazed openings

**Impact Consequences:** Style of roof should be evident if accessibility allows

**Recommended Action:** Predominant Roof Covering should be viewable if access allows

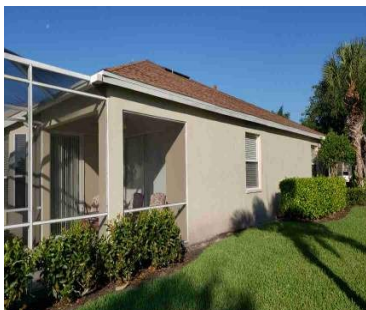
3.

**Location:** Exterior **System:** Wind Mitigation **Condition:** Left

**Explanation:** Photo of left Side showing Glazed and Non Glazed openings

**Impact Consequences:** Style of roof should be evident if accessibility allows

**Recommended Action:** Predominant Roof Covering should be viewable if access allows

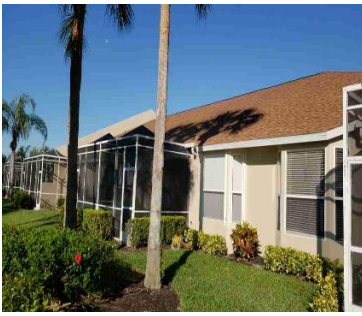
4.

**Location:** Exterior **System:** Wind Mitigation **Condition:** Back  
**Explanation:** Photo of back showing Glazed and Non Glazed openings  
**Impact Consequences:** Style of roof should be evident if accessibility allows  
**Recommended Action:** Predominant Roof Covering should be viewable if access allows

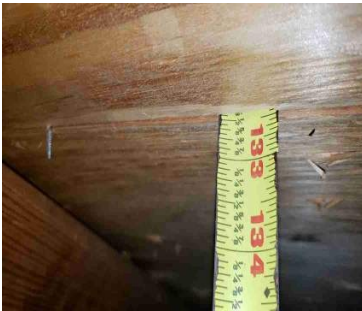
## 5.

**Location:** Attic **System:** Wind Mitigation **Condition:** Photo Of Plywood Thickness  
**Explanation:** Field Measurement  
**Impact Consequences:** NA  
**Recommended Action:** NA

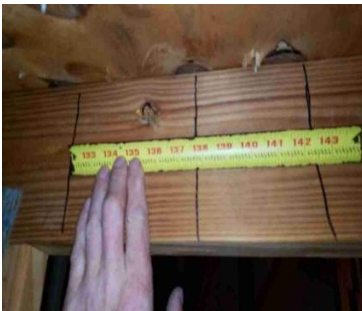
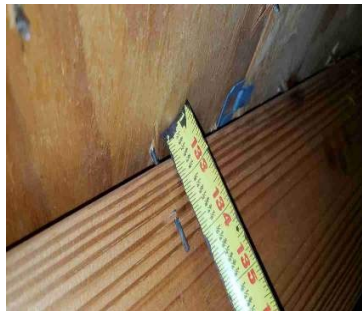
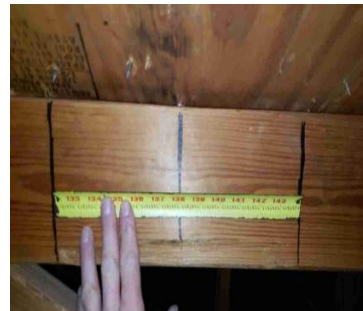
## 6.

**Location:** Attic **System:** Wind Mitigation **Condition:** Photo showing detail of a Field Nailing  
**Explanation:** Field Nailing Detail Photo  
**Impact Consequences:** No Comment  
**Recommended Action:** No Comment

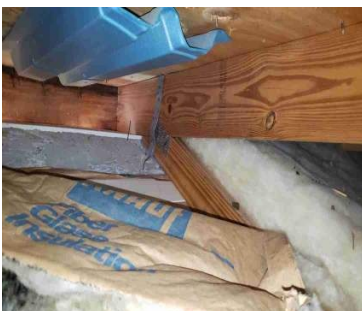
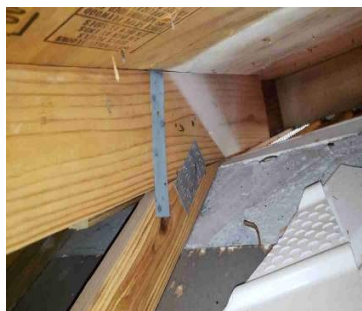
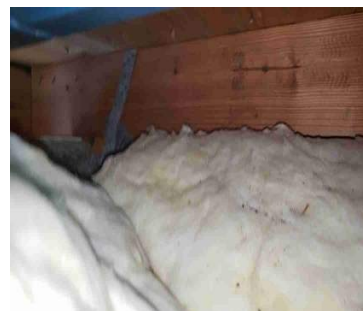
## 7.

**Location:** Attic **System:** Wind Mitigation **Condition:** Photo showing detail of a Single Wrap Detail  
**Explanation:** Single Wraps Metal Straps must be secured to every rafter and or truss with a minimum of 3 nails wrapping over and securing to the opposite side of the rafter and or truss with a minimum of 1 nail. The Strap must be attached to the top

plate of the wall frame or embedded in the bond beam in at least one place.
