Subject Property

1986 to 1966
Morning Sun Lane
Naples, FL
34119

Uniform Mitigation Verification Inspection Form

Inspection Date: 02/15/2016		Report Number 263	
Owner Information			
Owner Name: Club Homes I		Contact Person: Club Homes I	
Address: 1986 to 1966 Morning Sun Lane		Home Phone:	
City: Naples	Zip: 34119	Work Phone:	
County:		Cell Phone:	
Insurance Company:		Policy #:	
Year of Home:	# of Stories: Single Floor	Email: jneubs@att.net

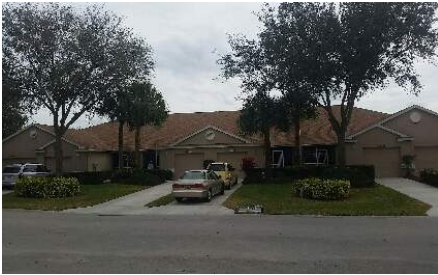
1.

Location: Throughout **System:** Wind Mitigation **Condition:** Front
Explanation: Photo of Front showing Glazed and Non Glazed openings
Impact Consequences: Style of roof should be evident if accessibility allows
Recommended Action: Predominant Roof Covering should be viewable if access allows

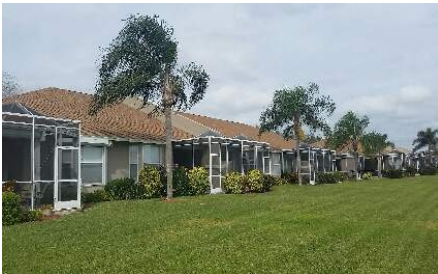
2.

Location: Throughout **System:** Wind Mitigation **Condition:** Back
Explanation: Photo of back showing Glazed and Non Glazed openings
Impact Consequences: Style of roof should be evident if accessibility allows
Recommended Action: Predominant Roof Covering should be viewable if access allows

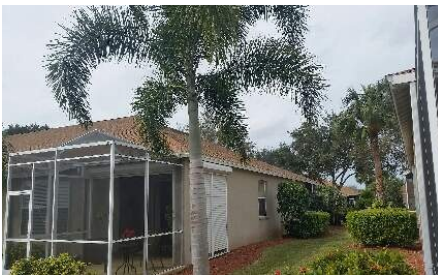
3.

Location: Throughout **System:** Wind Mitigation **Condition:** Left
Explanation: Photo of left Side showing Glazed and Non Glazed openings
Impact Consequences: Style of roof should be evident if accessibility allows
Recommended Action: Predominant Roof Covering should be viewable if access allows

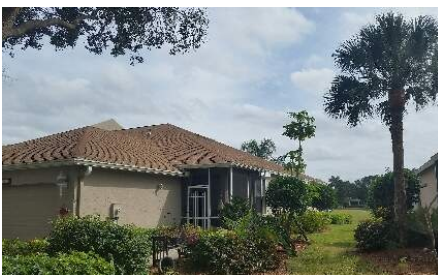
4.

Location: Throughout **System:** Wind Mitigation **Condition:** Right
Explanation: Photo of right Side showing Glazed and Non Glazed openings

Impact Consequences: Style of roof should be evident if accessibility allows
Recommended Action: Predominant Roof Covering should be viewable if access allows

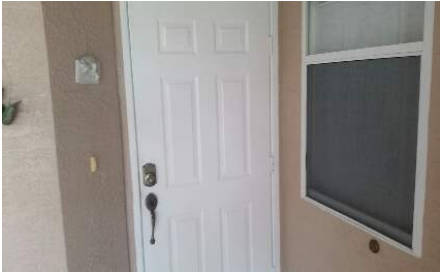
5.

Location: Throughout **System:** Wind Mitigation **Condition:** Detail photo of Door
Explanation: Evidence of hurricane protection if applicable
Impact Consequences: No Comment
Recommended Action: No Comment

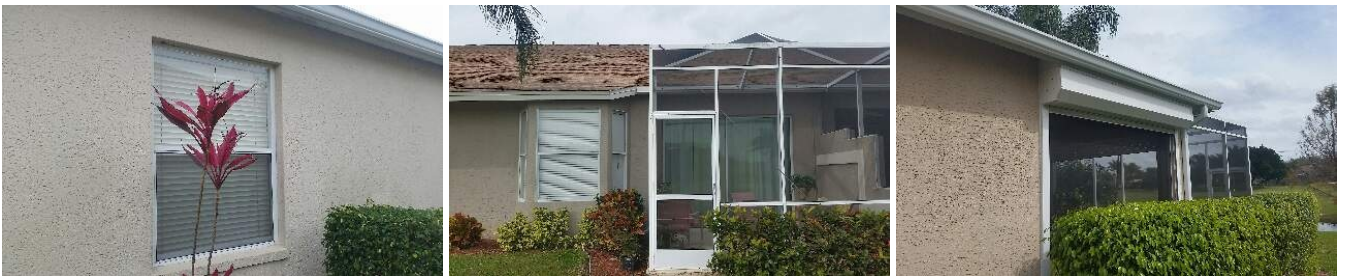
6.

Location: Throughout **System:** Wind Mitigation **Condition:** Detailed Photo Of Glazed Opening
Explanation: Close up detailed photo of glazed exterior opening
Impact Consequences: Photo showing details of glazed exterior openings.
Recommended Action: For Review

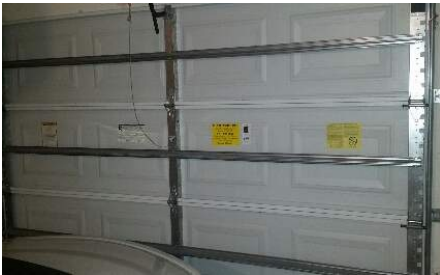
7.

Location: Throughout **System:** Wind Mitigation **Condition:** Photo showing details of Garage Door
Explanation: No Comment
Impact Consequences: No Comment
Recommended Action: No Comment

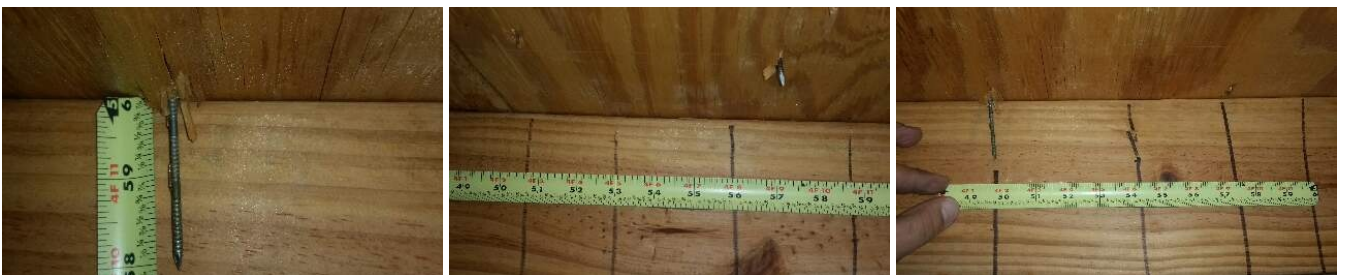
8.

Location: Throughout **System:** Wind Mitigation **Condition:** Photo showing detail of a Field Nailing
Explanation: Field Nailing Detail Photo
Impact Consequences: No Comment
Recommended Action: No Comment

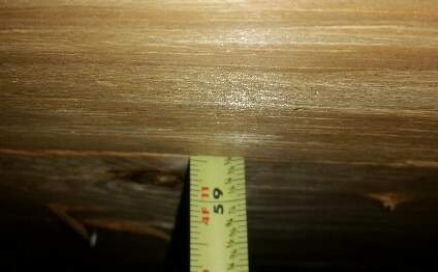
9.

Location: Throughout **System:** Wind Mitigation **Condition:** Photo Of Plywood Thickness

Explanation: Field Measurement

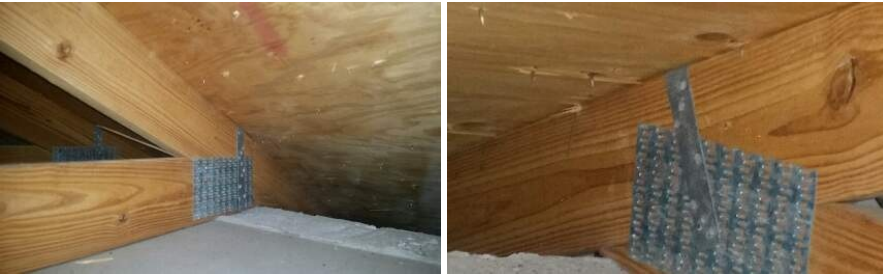
10.

Location: Throughout **System:** Wind Mitigation **Condition:** Photo showing detail of a Single Wrap Detail

Explanation: Single Wraps Metal Straps must be secured to every rafter and or truss with a minimum of 3 nails wrapping over and securing to the opposite side of the rafter and or truss with a minimum of 1 nail. The Strap must be attached to the top plate of the wall frame or embedded in the bond beam in at least one place.
